Operation of SuperKEKB in Phase 2

Y. Funakoshi for the SuperKEKB commissioning team
Accelerator Laboratory, KEK
2018.09.26@eeFACT 2018

Contents

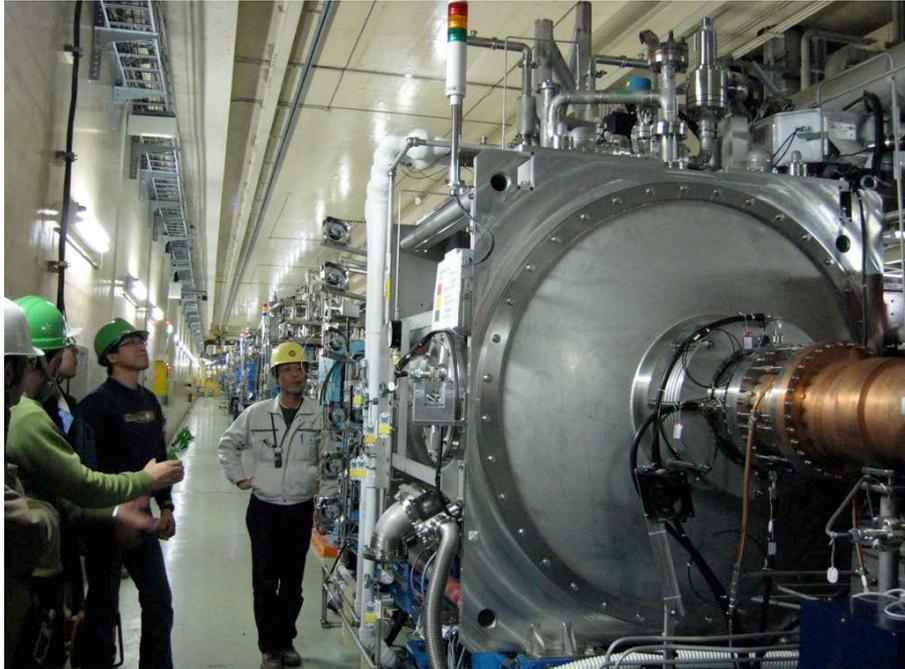
HER (e^- , 8 GeV)

Finally two crab cavities were installed in KEKB,
one for each ring in January 2007
